SUPPLEMENTARY MACHINE  
SERVICE BULLETIN #112-A.

SUBJECT: Adjustment of Lock  
for Clear-out Me-  
chanism in C and E  
Models.

DATE: March 27, 1931.

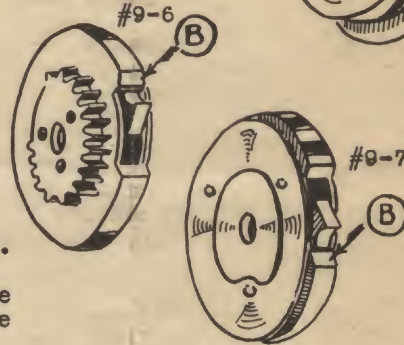
Item 1. When operating the center clear key, if the drum, #9-5, fails to rotate and a clicking sound is noted it is caused by the nose on the #9-11 being held by the edge of the slot in the drum.

Item 2. When operating either the registering dial or counting dial clear key, if the drums, #9-6 or #9-7, do not rotate and a clicking sound is noted, it is caused by either the nose on the #9-12 or #9-13, (or both) being held by the edge of the slot in the drum.

Item 3. When the machine is in regular operation, the #9-11 must hold the #9-5 drum from rotating. On account of the friction applied to the #9-5 there is a possibility of it camming out the #9-11 by contact at point "C".

To eliminate this condition, break the edge at point "A" by stoning until the drum operates freely.

To eliminate this condition, break the edge at points "B" by filing until the drums operate freely.

CAUTION: Do not file the opposite edges of the slots in the drums, and do not file points "B" any more than is absolutely necessary.

This can be eliminated by carefully grinding away the top of the #9-11 as shown by the dotted line.

NOTE: This grinding must not come below the radius of point "C" and should be slightly tapered to the rear of the nose. Grinding should be performed slowly and the part dipped in water frequently to eliminate the possibility of it overheating which would destroy the temper of the material.
